Safety Alert

Occurrence No.
037

Type of incident	Counterfeit “Crosby” Shackles	Category	Near Hit unsafe act/condition
-------------------------	--------------------------------------	-----------------	--------------------------------------

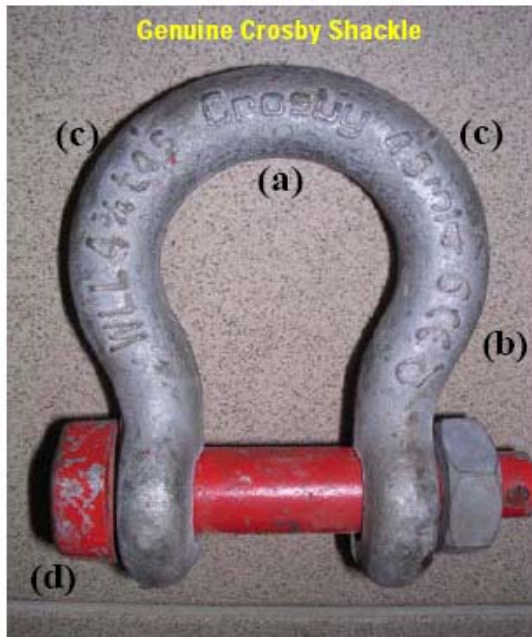
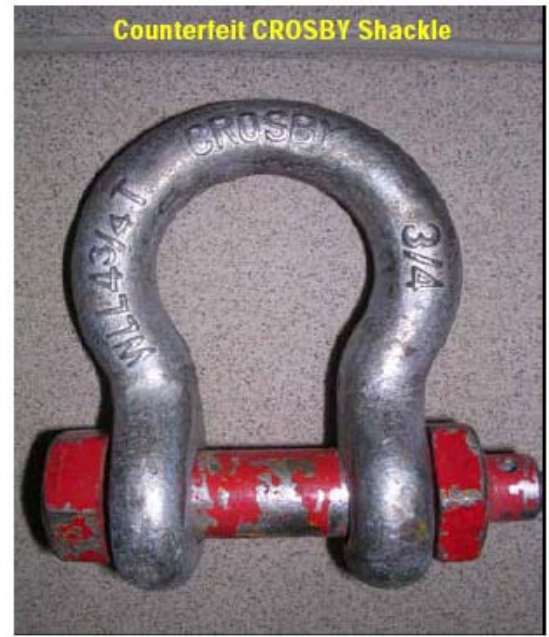
Counterfeit Crosby Shackles have been found at a number of locations in Europe. These shackles are **NOT** up to required standards and it is mandatory that they be immediately removed from service. The counterfeit shackles can fail at as low as just 40% of their stated rating, causing a potentially catastrophic outcome. The most obvious difference is that the counterfeit shackle has the word “CROSBY” all in capital (Upper Case) lettering. The genuine shackle only has the “C” of “Crosby” capitalized.

The points to look for in deciding whether you have a Crosby Shackle or a copy are:

- On the face, (a) the Crosby Name should be embossed as per the Crosby Logo, (b) The CE mark should appear along with (c) markings of the 45 degree angles
- On the rear of the shackle should appear 2 different groupings of IDs (3 for Belgium manufacture) providing full traceability of the shackle.
- The pin should also be stamped (d) on the head with a traceable ID number.

- Inform immediately all contractors on site of this safety alert
- All Site SHE Staff to coordinate and document a complete inspection of shackles in their locations and destroy any suspected counterfeit shackles.
- Liaise with your Lifting Equipment Specialists.
- Add the requirement to sample a selection of shackles to your Planned General Inspection checklists to ensure on-going vigilance.
